HILLTOP RETAIL CENTER GLENDALE HEIGHTS, ILLINOIS

*Property Management & Leasing
Evaluation & Recommendation Report*

January 11, 2006

PROPERTY EVALUATION & RECOMMENDATIONS

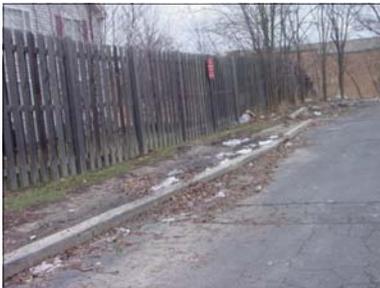
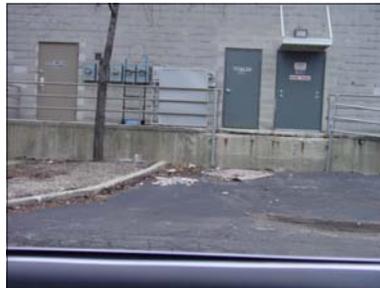
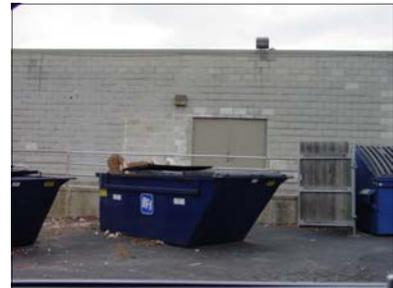
The overall condition of the exterior grounds was fair on the date of inspection. There was a moderate amount of debris throughout the parking lot and storefront sidewalk areas. The Management Team strongly recommends installing approximately six (6) commercial grade, aggregate garbage can receptacles along the storefront sidewalk. This will provide patrons the option of disposing their debris rather than throwing it on the ground. The initial expense will save a tremendous amount of operating expense to clean the property.

Ownership should consider an initial “clean up” of the exterior grounds, as well as implementing a bi-weekly inspection/debris removal program. A property of this size and nature generally requires a “clean up” two times per week.

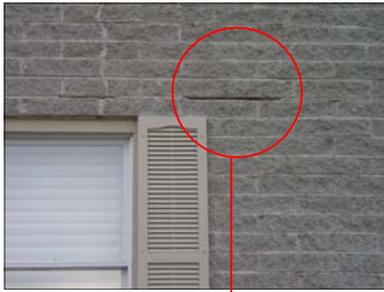
Tuck-Point

1. There is a moderate amount of tuck-point work that should be conducted to eliminate further damage and cost. The repairs should be conducted on block and brick portions of the property.

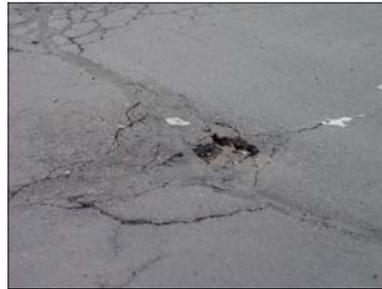
Asphalt Repairs

3. There are several areas of asphalt that require serious repair. Most areas can be temporarily repaired by installing cold patch material.
4. The Management Team recommends labeling all of the back doors at the property for identity purposes.

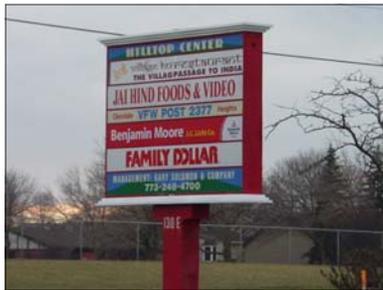
Marquee Sign

2. The marquee pylon sign located in front of the property still displays the previous management/leasing name and contact information. The information should be updated immediately.
